# WATER OPERATION AND MAINTENANCE

**BULLETIN NO. 126**

DECEMBER 1983

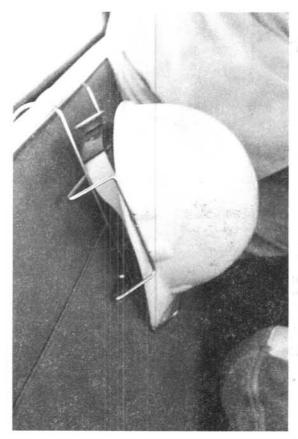
Figure 10.-Hardhat holder.

A device that can be hung on the back of a seat, as shown in figures 10 and 11, can be bought at most hardware stores. It will cut down on the beating a hat gets from dust and rolling around loose.

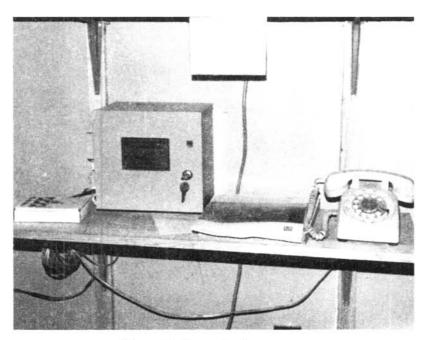
Figure 15.—Automatic alarm system.

In a recent examination of the river pumping plant at the Michaud Flats Project, the examination team noticed an automatic alarm system in operation. This system is unique because it will dial several telephones and report problems at the pumping plant, by way of a recorded message.
